Less kitchen smell thanks to special UV-lamps

Benefits of the Excelitas Kitchen Control System

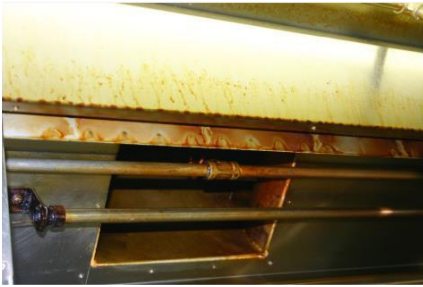
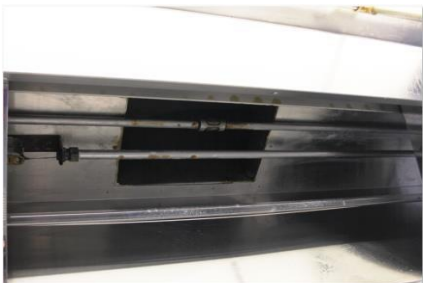
In October 2010, a trial device was installed at the Heraeus canteen at Hanau. One of the extraction hoods, located directly above the deep fat fryer, was equipped with our VUV lamps. The ventilation system was installed by UV-Consulting Peschl, a long-standing distribution partner of Excelitas. The specialist company combined all necessary components to form a retrofit kit and developed a control system for safe operation in accordance with DIN standards (or DIN 18869-7:2006-07). The pictures on the left show the kitchen air extraction hood exhaust air duct above the deep fat fryer prior to installation (on top) and after installation of the VUV lamp after 3,000 hours of operation.
